Restoring Fatigue Performance Of Corrosion Damaged Aa7075-T6 and Fretting in 4340 Steel with Low Plasticity Burnishing

Paul S. Prevéy
Lambda Research

John T. Cammett
NAVAIR

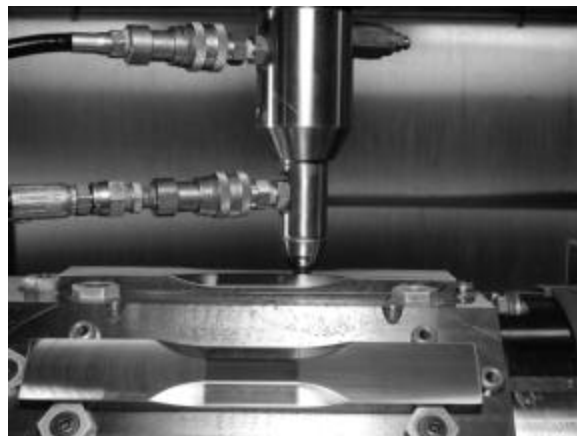
Figure 1 – LPB processing of fatigue samples with a single point contact LPB tool in a 4-axis CNC mill.

Using CNC positioning, the tool path is controlled so that the surface is covered with a series of passes at a separation maintained to achieve maximum compression with minimum cold working. The tool may be moved in any direction along the surface of a complex work piece, as in a typical multi-axis CNC machining operation. The LPB processing of fatigue

specimens used in this investigation is depicted in Figure 1.

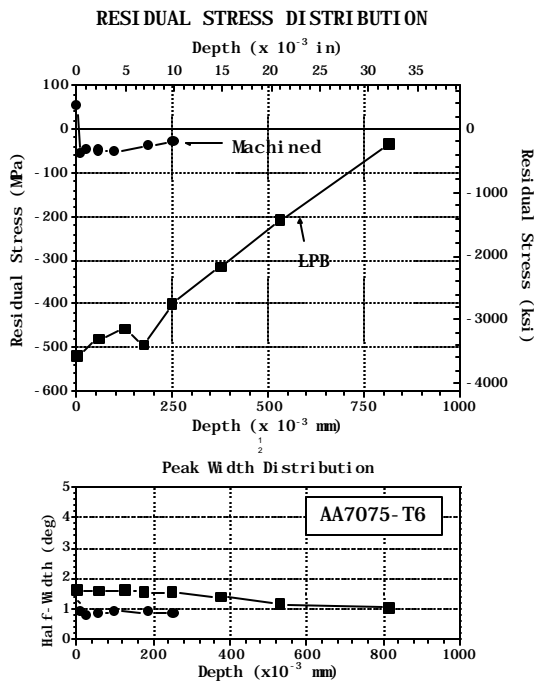
Figure 2 - Residual stress and half width distribution in machined and LPB processed AA7075-T6.

The residual stress distributions developed by machining and LPB processing of 7075-T6 are shown in Figure 2. Machining of 7075-T6 produced low tension on the surface and compression of less than -68 MPa (-10 ksi) below the surface. In contrast, LPB produced maximum compression on the order of -480 MPa (-70 ksi) between the surface and a depth of nominally 0.2 mm (0.008 in.). Maximum cold work occurs from the surface through the region of maximum compression, and then diminishes with depth. X-ray diffraction measurement could not be made reliably below a depth of 0.5 mm (0.02 in.) in the 7075-T6 because of the coarse grain size encountered at depths beneath the deformed surface layer.

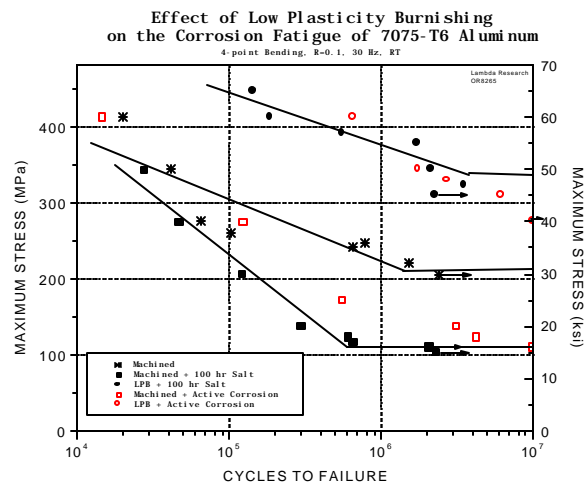
Figure 4 - High cycle fatigue results for salt fog pitted and active corrosion fatigue of machined 7075-T6 with and without LPB processing prior to exposure to corrosion.

The S/N curves generated for 7075-T6 in both the baseline (as-machined) and LPB conditions, after 100 hr salt fog exposure or active corrosion fatigue, are presented in Figure 4. Fatigue tests were continued for a minimum of 2.5×10^6 cycles with a maximum run-out at 1.2×10^7 cycles. The fatigue data are presented as semi-logarithmic S/N curves in terms of the maximum stress.

The S/N curves for samples with pitting from prior salt fog exposure appeared to exhibit an endurance limit, implying infinite life below some threshold stress level. The S/N curves for samples exposed to active corrosion fatigue during testing do not appear to have an endurance limit, as is commonly observed in studies of corrosion fatigue.¹⁶ In the discussion that follows, the results are considered and compared in terms of the fatigue life at nominally 2×10^6 cycles.

The machined (end milled) surface condition produced an apparent endurance limit on the order of 200 MPa (30 ksi). Salt fog exposure for 100 hrs reduced the endurance limit to nominally 100 MPa (15 ksi), half that of the original machined surface

before exposure to salt fog generated pitting corrosion. Loss of nominally half the extended life fatigue strength following salt fog corrosion pitting appears to be typical of the degradation reported in the literature³. The fractional loss of fatigue life at stress levels above the endurance limit increased rapidly as the maximum stress level reduced, reaching an order of magnitude at the 200MPa (30ksi) endurance limit

Active corrosion fatigue in 3.5% NaCl solution, with no prior corrosion damage, degraded the fatigue strength relative to the as-machined condition by an amount only slightly less than prior pitting corrosion up to a life of 10^7 cycles. A failure occurred in active corrosion fatigue at the nominal 100 MPa (14.5 ksi) endurance limit for pitting corrosion. The data appear to suggest further reduction in fatigue strength with increasing life and the absence of an endurance limit for active corrosion fatigue of the machined 7075-T6 surface.

LPB prior to salt fog pitting resulted in a 70% increase in the endurance limit, from nominally 200 MPa (30 ksi) to over 330 MPa (48 ksi). LPB prior to corrosion increased the fatigue life at stress levels above the endurance limit 310 MPa (45 ksi) by two orders of magnitude, or one hundred times that of the baseline machined surface.

A comparable benefit in fatigue performance was observed for LPB prior to active corrosion fatigue in 3.5% NaCl solution. As noted earlier, a true endurance limit may not exist for the active corrosion fatigue mechanism; however, the fatigue strength at 10^7 cycles was at least 282MPa (41ksi). Fatigue lives were 100 times that of the baseline for stress levels above 275 MPa (40 ksi).

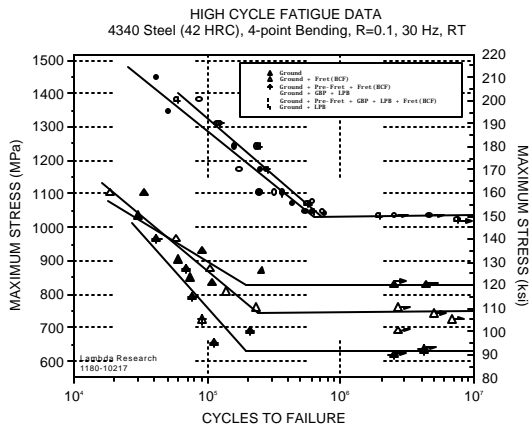
Figure 6 – 4340 steel fretting fatigue results, as ground and with prior LPB treatment. Multiple fretting exposures simulate service damage, overhaul, and return to service.

The fretting fatigue results for 4340 steel are shown in Figure 6. The ground baseline samples produced an endurance limit of 827 MPa (120.0 ksi). Fretting of as-ground samples during fatigue testing reduced the endurance limit to nominally 758 MPa (110.0 ksi).

Pre-fretting followed by fretting during fatigue testing (simulating returning a fretted part to continued service) reduced the HCF endurance limit further to nominally 620 MPa (90.0 ksi), a loss of 25% of the initial fatigue strength.

LPB, either before or after fretting, produced an endurance limit of nominally 1033 MPa (150.0 ksi), 25% higher than ground 4340 without fretting damage. Even with fretting both before and after LPB, intended to simulate application of LPB of a component during overhaul followed by return to service, LPB gave the same 25% endurance limit increase, indicating complete mitigation of the fretting fatigue debit.

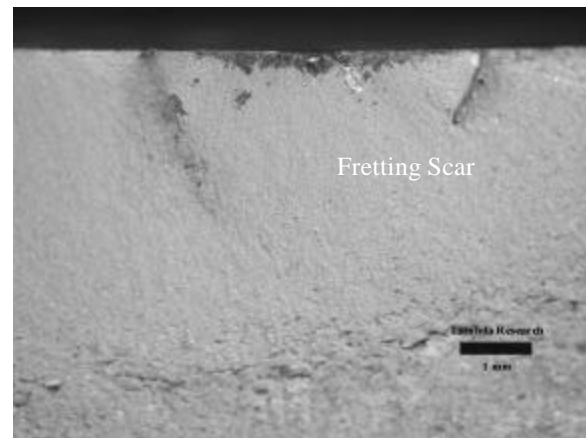
Figure 7 – Fracture face of a 4340 steel fretting fatigue sample showing initiation from the edge of the fretting scar.

Fatigue initiated from the edge of the fretting scar in all of the 4340 samples without LPB. A typical fracture face, with the fretting scar visible at the top, is shown in Figure 7. Fatigue initiated in all of the LPB samples subsurface, just below the compressive layer, indicating a fatigue strength for the LPB surface higher than indicated by the results. The subsurface failures are interpreted as a limitation of the test technique and sample design which combined to allow the maximum tension to occur below the highly compressive test surface.
