APPLICATION OF LOW PLASTICITY BURNISHING (LPB) TO IMPROVE THE CORROSION FATIGUE PERFORMANCE AND FOD TOLERANCE OF ALLOY 450 STAINLESS STEEL

N. Jayaraman (njayaraman@lambda-research.com)
Paul S. Prev y (pprevey@lambda-research.com)

Lambda Research
5521 Fair Lane, Cincinnati, OH 45227-3401

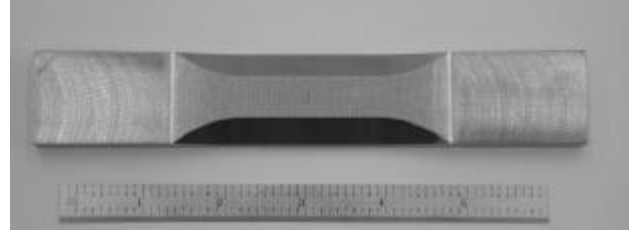
Figure 1c: Photograph of a typical thick section specimen

Thick section fatigue specimens with nominal dimensions of 1.25 in X 0.375 in. X 8 in. (31.25 mm X 9.375 mm X 200 mm) were finish machined out of these bars by low stress grinding. A typical fatigue specimen is shown in Figure 1c, which has a trapezoidal cross section in the gage region. This special design enables the testing of surface treated specimens with deep compressive residual stresses on the surface. The trapezoidal cross section HCF sample with compressive surface residual stresses was designed to force fatigue failures to initiate in the gage section under 4-point bend loading.

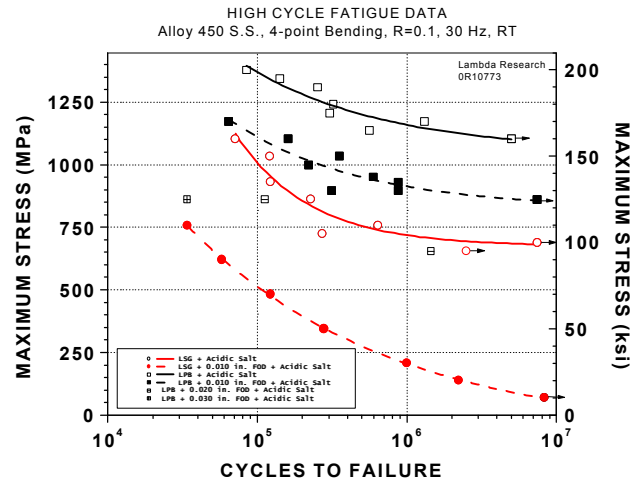
Figure 3. Corrosion fatigue results plotted in the form of S-N curves. Note that the LPB specimens substantially outperformed the LSG specimens.

Figure 3 shows the corrosion fatigue performance of alloy 450 stainless steel (H1050) in the form of S-N curves. The baseline material (LSG) performance with and without the EDM notch is compared with similarly tested specimens with LPB treatment. The unnotched LSG condition shows a fatigue strength (endurance limit at about 10^7 cycles) of about 100 ksi (~700 MPa). It is obvious that the introduction of a semi-elliptical EDM notch of nominal size $a_0 = 0.010$ in. (0.25 mm) and $c_0 = 0.030$ in. (0.75 mm) drastically decreases the corrosion fatigue strength to about 10 ksi (~70 MPa). The fatigue lives at higher stresses show a corresponding decrease by over an order of magnitude.

In contrast, the unnotched set of LPB specimens show a fatigue strength of about 160 ksi (~1,100 MPa). The introduction of the EDM notch only marginally reduced the fatigue strength to a value of 125 ksi (860 MPa). It is particularly noteworthy that this fatigue strength of notched LPB specimens is much better than the unnotched LSG specimens. Additionally, the two data points for LPB specimens with semi-elliptical EDM notch of $a_0 = 0.020$ in. (0.5 mm) and $c_0 = 0.060$ in. (1.5 mm) tested at 120 ksi (~825 MPa) and 95 ksi (~655 MPa) show fatigue lives comparable to similarly tested LSG specimens, within the limits of experimental scatter. However, the LPB specimen with an EDM notch of $a_0 = 0.030$ in. (0.75 mm) and $c_0 = 0.090$ in. (2.25 mm) when tested at 120 ksi (~825 MPa) showed a substantial decrease in fatigue life

The corrosion fatigue results presented in Figure 3 and the fractographic observations in Figures 4-6 are fully consistent with the residual stress results shown in Figure 2. From previous research, it is generally known that the fatigue strength of surface treated parts is approximately the same as the compressive residual stress. Correspondingly, the surface residual stress of -140 ksi (-965 MPa) and -175 ksi (-1,200 MPa) for the LPB treated specimens correlate quite well with the fatigue strength of LPB treated (unnotched) specimens at a value of about 160 ksi (~1,100 MPa). Similarly, for a 0.010 in. (0.25 mm) deep notch, Figure 3 shows a residual stress in the range of 120 ksi to 150 ksi (~825 to 1035 MPa). The corresponding corrosion fatigue strength is indeed around 125 ksi (~860 MPa). Cutting a deeper notch at 0.020 in. (0.5 mm) depth, the residual stress from Figure 3 shows a value of about -90 ksi (~620 MPa); correspondingly, the two data points for the 0.020 in. deep notch appear to show a tendency towards a fatigue strength of about 90 ksi. Figure 3 shows that at 0.030 (0.75 mm) in deep notch, the residual stress is about -30 ksi (~205 MPa), and correspondingly, the corrosion fatigue performance is expected to be very poor.

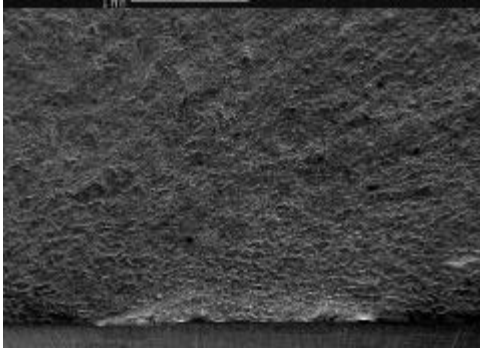
Figure 4a: Fracture surface showing multiple initiation sites.

Figures 4, 5 and 6 show SEM fractographs of unnotched LSG, LPB, and notched specimens, respectively. Figures 4a – c show the fracture features of an unnotched LSG specimen. It is evident from Figure 4a, that the fracture process involved multiple crack initiation from corrosion pits on the surface. As seen in Figure 4b, the corrosion pit formation was further aided by the presence of grind marks on the surface.
