# The Influence of Surface Enhancement by Low Plasticity Burnishing on the Corrosion Fatigue Performance of AA7075-T6

Paul S. Prevéy (pprevey@lambda-research.com)  
Lambda Research, 5521 Fair Lane, Cincinnati, Ohio 45227

John T. Cammett (cammettjt@navair.navy.mil)  
Naval Aviation Depot, PSC Box 8021, MCAS Cherry Point, NC 28533

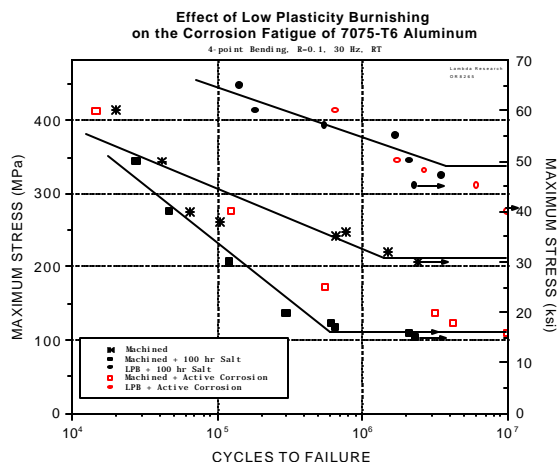
Figure 7 - High cycle fatigue results for salt fog pitted and active corrosion fatigue of machined 7075-T6 with and without LPB processing prior to exposure to corrosion.

The S/N curves generated for 7075-T6 in both the baseline as-machined condition and with LPB after 100-hr. salt fog exposure or prior to active corrosion fatigue are presented in Figure 7. Fatigue tests were continued for a minimum of  $2.5 \times 10^6$  cycles if no failure occurred first. Maximum run-out sustained was  $1.2 \times 10^7$  cycles.

The S-N curves for samples with pitting from prior salt fog exposure appeared to exhibit an endurance limit, implying infinite life below that stress level. The S-N curves for samples exposed to active corrosion fatigue during testing do not appear to have an endurance limit, as is commonly reported in studies of corrosion fatigue.<sup>16</sup> Because fatigue tests were limited in both number of samples and applied load cycles to nominally  $1.0 \times 10^7$  cycles, the presence of a true endurance limit cannot be confirmed without additional testing. In the discussion that follows, the results are considered and compared in terms of the fatigue life at nominally  $2 \times 10^6$  cycles. The fatigue data in Figure 7 are presented as semi-logarithmic S-N curves at stress ratio, R, of 0.1, in terms of the maximum stress.

order of 200 MPa (30 ksi). Salt fog exposure for 100 hrs. reduced the endurance limit to nominally 100 MPa (15 ksi), half that of the original machined surface before exposure to salt fog. The fractional loss of fatigue life at stress levels above the endurance limit for salt fog exposed samples increased rapidly with decreasing maximum stress level, reaching an order of magnitude at the 200 MPa (30ksi) endurance limit. Active corrosion fatigue in 3.5% NaCl solution, with no prior corrosion damage, degraded the fatigue strength relative to the as-machined condition by an amount only slightly less than for prior pitting corrosion from 100 hr. salt fog exposure up to a life of  $10^7$  cycles. A failure occurred in active corrosion fatigue at  $10^7$  cycles, i.e., at the nominal 100 MPa endurance limit for pitting corrosion. The data appear to suggest both further reduction in fatigue strength with increasing life and the absence of an endurance limit for active corrosion fatigue. LPB prior to salt fog pitting resulted in a 70% increase in the endurance limit, from nominally 200 MPa (30 ksi) to over 330 MPa (48 ksi). The fatigue life at stress levels above the 310 MPa (45 ksi) endurance limit for LPB prior to corrosion is two orders of magnitude (100X) greater than that of the baseline machined surface. A comparable benefit in fatigue performance was observed for LPB prior to active corrosion fatigue in 3.5% NaCl solution. As noted earlier, a true endurance limit may not exist for the active corrosion fatigue mechanism, however, the fatigue strength at  $10^7$  cycles was at least 282 MPa (41ksi). Fatigue lives were 100 times that of the baseline machined surface for stress levels above 275 MPa (40 ksi).
