AN OVERVIEW OF THE USE OF ENGINEERED COMPRESSIVE RESIDUAL STRESSES TO MITIGATE SCC AND CORROSION FATIGUE

N. Jayaraman (njayaraman@lambdatechs.com), Director of Materials Research
Paul S. Prevéy, President, Director of Research
Lambda Research, 5521, Fair Lane, Cincinnati, OH 45227 – 3401

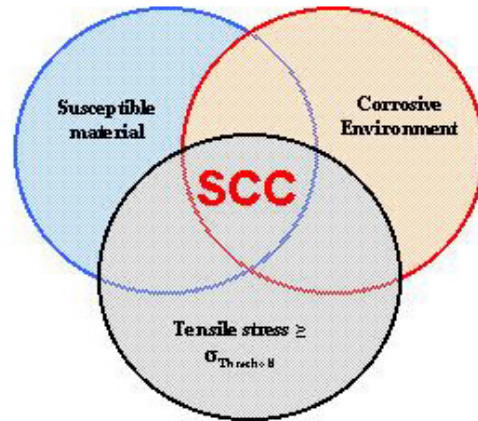
Figure 1 – SCC susceptibility diagram illustrating the need for the combination of a susceptible material, corrosive environment, and threshold tensile stress to cause SCC.

The phenomenon of SCC is generally understood to be the result of a combination of a material susceptible to SCC, exposed to corrosive environment, which is also subjected to a tensile stress above certain a threshold level. This is succinctly illustrated in Figure 1. Earlier solutions to this problem include the attempts to reduce the susceptibility to corrosion by modifying the material through alloy chemistry, microstructure by heat treatment, or protect the material from the environment by protective coatings.

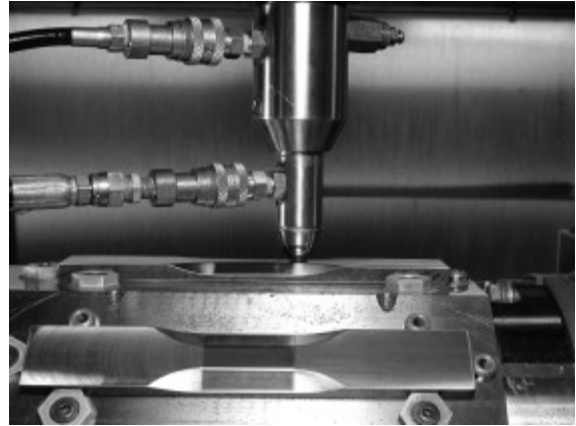
Figure 2 – LPB processing of fatigue samples with at single point contact LPB tool in a 4-axis CNC mill.

Using CNC positioning, the tool path is controlled in the LPB process so that the surface is covered with a series of passes at a separation maintained to achieve maximum compression with minimum cold working. The tool may be moved in any direction along the surface of a complex work piece, as in a typical multi-axis CNC machining operation. The LPB processing of fatigue specimens used in this investigation is depicted in Figure 2.

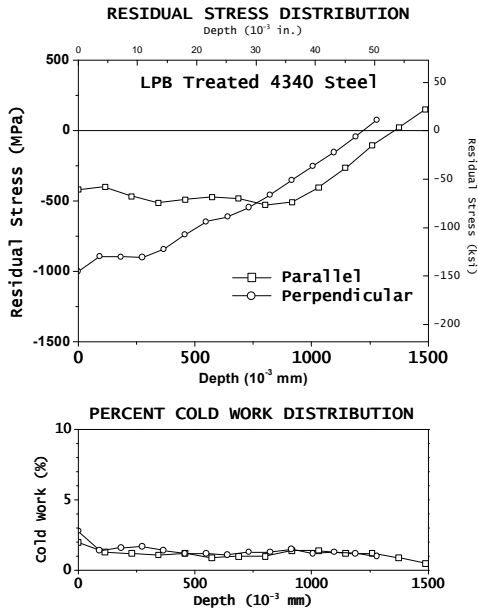
Figure 3 - Plots of residual stress and % cold work distribution in LPB treated 4340 Steel

Figure 3 shows the residual stress profiles in LPB treated 4340 steel. Measurements made both parallel and perpendicular to the treatment directions are presented. In both orientations, compression to depths greater than 0.050 in. (1.25 mm) is seen. The corresponding % cold work is well below 3% even at the surface of the specimens. Figures 4 and 5 show the fatigue performance in the as-machined and LPB treated conditions before and after salt-fog exposure to 100 and 500 hours. It is evident from both Figures 4 and 5 that prior corrosion damage leads to substantial debit in fatigue performance. LPB treatment is seen to result in significantly better fatigue performance for the as-machined condition. Also, both the S-N data and the bar chart indicate complete mitigation of damage from salt-fog exposure in LPB treated material.

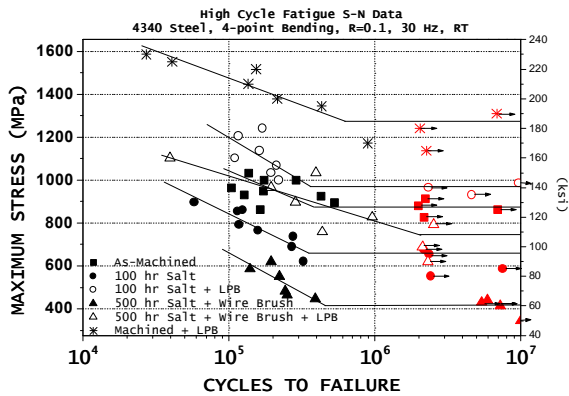
Figure 4 – S-N plots of salt fog exposed 4340 steel.

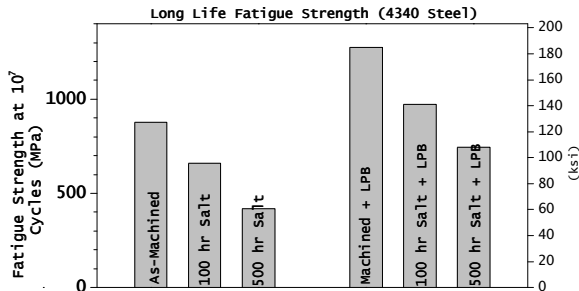
Figure 5 - Bar chart showing the relative fatigue strengths salt-fog exposed 4340 steel)

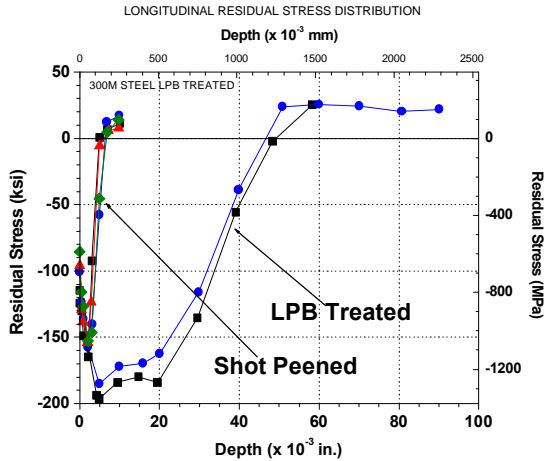
Figure 6 - RS profiles of shot peened and LPB treated 300M HSLA steel specimens before and after 48 hours of thermal exposure to 400F

Figure 6 shows a comparison of residual stress profiles from SP and LPB treated 300M HSLA steel specimens. LPB treated specimens show compression to a depth of over 0.04 in. (1.2 mm) while the shot peening treatment resulted in only 0.005 in. (0.1 mm) deep compression. In both cases, thermal exposure to 400°F for 48 hours did not result in significant stress relaxation. Figure 7 shows a bar chart comparing the fatigue strengths of baseline material in the presence of a 0.01 in. (0.25 mm) deep FOD and/or active salt corrosion, with similar test conditions for shot peened and LPB treated specimens. Both active salt corrosion and FOD have the effects of decreasing the fatigue strengths by a factor of 5, while the combined effects of FOD and active corrosion are even worse. Shot peening (SP) has some marginal beneficial effects when only active corrosion is considered, while no benefit is seen with the presence of FOD and combined presence of FOD and active corrosion. Even Ni-Cr plating had no benefit in mitigating corrosion fatigue damage. With LPB treatment, almost all the damage from active salt corrosion, FOD, and the combined damage conditions are fully mitigated. The Ni-Cr plating on top of LPB treated surface performed better than with the SP surface. Fractography indicated that all corrosion fatigue cracking damage initiated from corrosion pits. LPB did not stop the formation of corrosion pits, rather the crack initiation and growth processes were completely stopped by the deep compressive residual stresses. The Ni-Cr plating was found to have numerous plating cracks, and again the corrosion pitting and SCC were not stopped by the plating process.

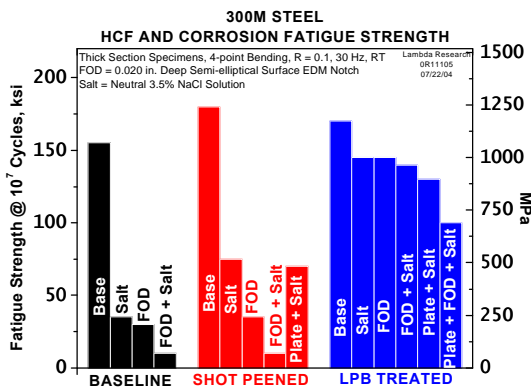
Figure 7 – Bar chart showing the fatigue strength of 300M HSLA steel.

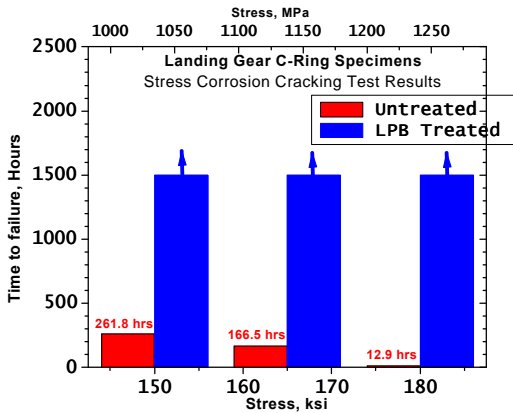
Figure 8 – SCC test results for 300M Steel

SCC studies on LPB treated 300M HSLA steel showed similar benefits. Figure 8 shows a bar chart of time to failure at different constant applied stresses on c-ring specimens. Untreated baseline specimens, when stressed at 150 ksi, 165 ksi and 180 ksi, failed after 261.8 hrs, 166.5 hrs, and 12.9 hrs of alternate immersion in neutral salt solution, while LPB treated specimens did not fail after 1,500 hrs of exposure. Efforts to increase the stresses to beyond 180 ksi resulted in permanent bending of the LPB treated specimens, rather than failure. Thus it is evident that LPB processing helps to completely mitigate the

SCC damage conditions in 300M HSLA landing gear steel.

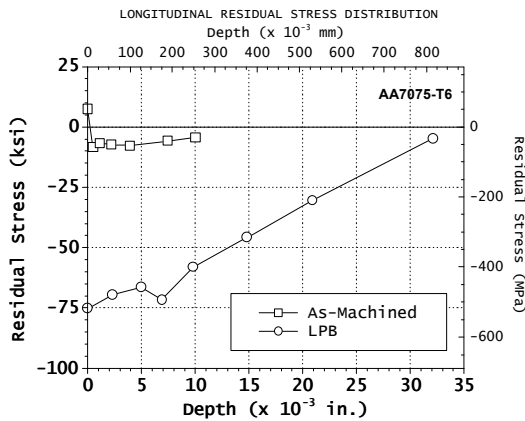
Figure 9 – RS distribution in AA7075-T6

Figure 9 shows the residual stress profiles of AA7075-T6 fatigue specimens in the as-machined condition and in the LPB treated condition. A depth of compression of nearly 0.035 in. (0.9 mm) was achieved with LPB treatment. Figure 10 shows the S-N data for AA7075-T6 specimens tested in the as-machined and LPB treated conditions in both active corrosion mode as well as with prior salt-fog exposure. In the as-machined condition both active corrosion and prior salt-fog exposure results in a significant drop in the fatigue performance so that the fatigue strength at 10^7 cycles drops by a factor of 2 from about 32 ksi to 16 ksi. With LPB treatment the HCF properties at all the cycle ranges are superior to even the as-machined condition. Evidently, the compressive residual stresses from LPB helped to not only mitigate the corrosion

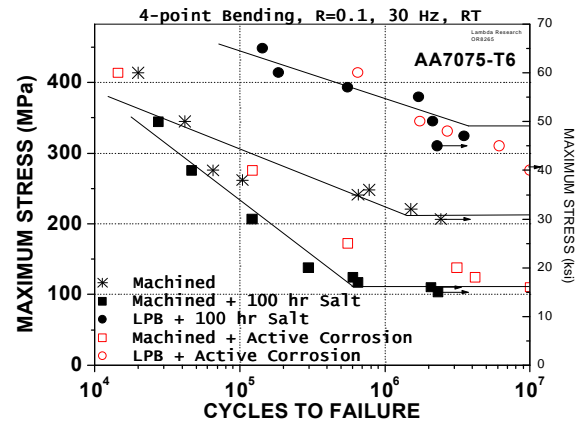
Figure 10 – S-N data for AA7075-T6

pitting damage, but also far exceed the baseline performance.

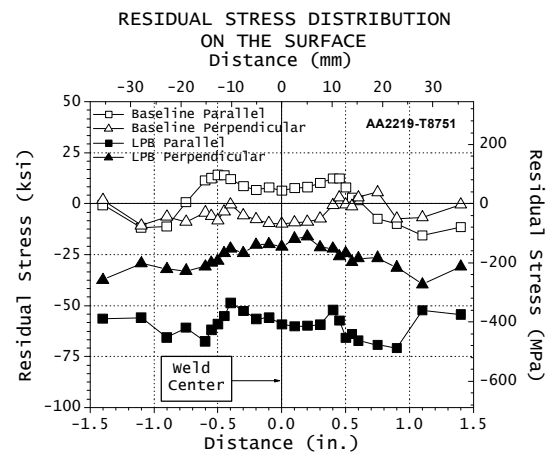
Figure 11 – Surface RS distribution in FSW plate AA2219-T8751.

Figures 11 and 12 show the residual stress distribution around the weld on the surface

and mid-thickness of a friction stir welded plate of AA2219-T8751. As seen in Figure 11, the surface tensile residual stresses created by the FSW process is completely eliminated and in place a compressive residual stress state is introduced by the LPB treatment. The LPB treatment did not affect the residual stresses in the mid-thickness plane.

The fatigue strength of baseline FSW is seen Figure 13 to drop from about 35 ksi to about 25 ksi in the presence of active corrosion. Both LPB treated FSW in baseline condition and in active corrosion conditions performed equally well and surpassed the performance of even the baseline FSW. At about 45 ksi, an improvement in the fatigue performance is evident. This improvement is attributed to the surface compressive residual seen in Figure 11.

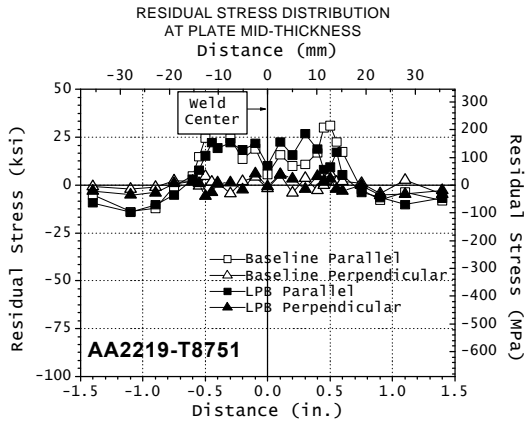
Figure 12 – Mid-thickness RS distribution in FSW AA2219-T8751

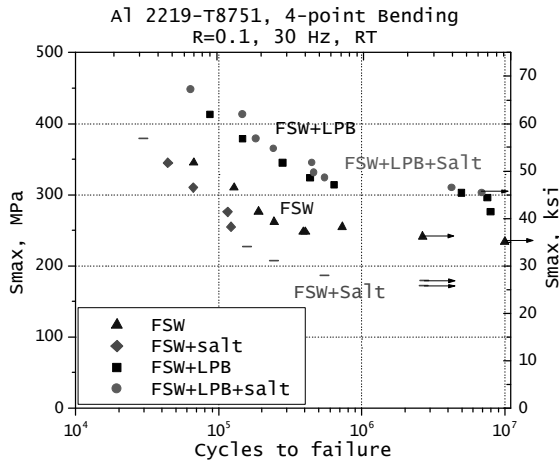
Figure 13 – S-N plots for AA2219-T8751

As indicated earlier, since corrosion fatigue is a surface phenomenon, subsurface tensile stresses, although not desirable, are not excessively harmful. Figure 13 compares the S-N plots of baseline FSW vs LPB treated FSW both with and without active corrosion.

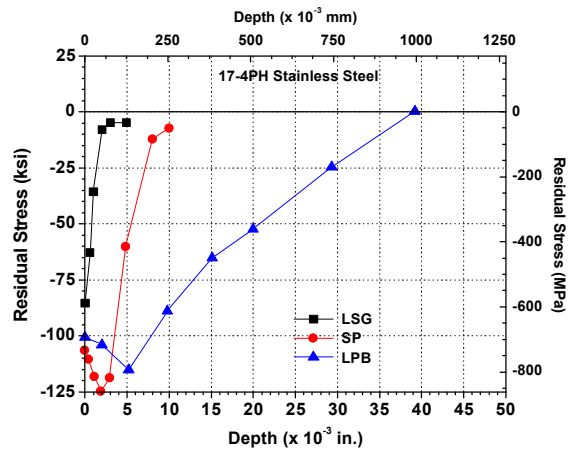
Figure 14 – RS profiles for surface treated 17-4PH SS

Figure 14 shows the residual stress profiles in low stress ground (LSG), SP, and LPB treated specimens. LPB treatment leads to a depth of compression of 0.040 in. (1 mm), while SP yields compression to a depth of 0.010 in. and LSG even less. The fatigue endurance strength for 10^7 cycles for the different treatments, active corrosion conditions, and FOD conditions reflect the effects of compression as seen in Figure 15. The baseline LSG material showed a fatigue strength of 150 ksi, which reduced to 100 ksi in active corrosion, and further degraded to less than 20 ksi in the presence of a 0.010 in. deep notch. The shot peened condition yielded similar results.

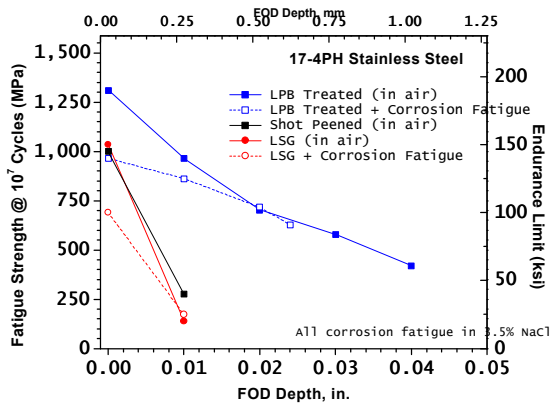
Figure 15 – Fatigue strength of 17-4PH stainless steel

In contrast, LPB showed a baseline fatigue strength of 175 ksi, which dropped to about 145 ksi in active corrosion, and experienced only nominal degradation in the presence of FOD. Even FOD of 0.040 in. depth only dropped the fatigue strength to 50 ksi. The improved performance of the LPB treated

specimens is attributed to the deep compression imparted by the LPB process.

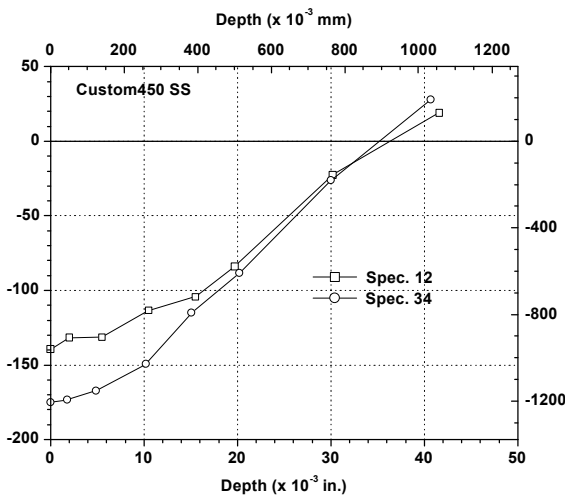
Figure 16 - Residual stress distribution for two LPB processed (and fatigue tested) specimens. Specimen #12 (LPB - no notch): Smax = 195 ksi (~1,345 MPa); Nf = 141,191 cycles. Specimen #34 (LPB + notch): Smax = 160 ksi (~1,100 MPa); Nf = 159,941 cycles

Similar to 17-4PH stainless steel, Custom450 stainless steel is a precipitation hardenable stainless steel. Figures 16 and 17 show the RS distribution from LPB and S-N plots for baseline (low stress ground – LSG) and LPB conditions. In Figure 16, residual stresses from fatigue tested LPB specimens are plotted as a function of depth. Very little differences are seen in both magnitude and depth of compression

between the two specimens. The fatigue properties of the LSG specimens in active corrosion in acid salt environment is affected by a factor of 10 in the presence of a 0.010 in. deep FOD. However, through the LPB process the fatigue strength is fully restored and exceeded even in the presence of 0.010 in. FOD. Figure 17 shows that even in the presence of 0.020 in. or 0.030 in. FOD, the fatigue lives are favorably comparable to the LSG unnotched condition.

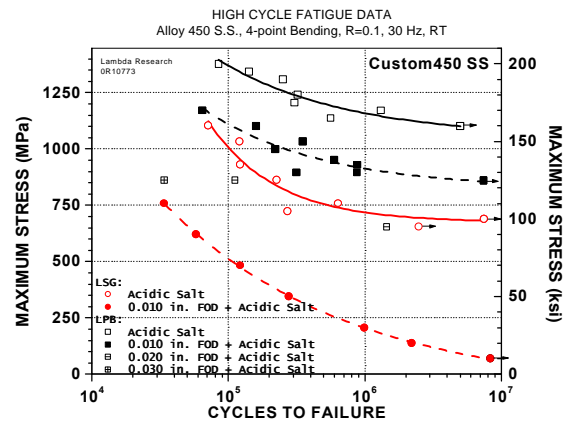
Figure 17 – S-N data for Custom 450 stainless steel.
